STILL LAKE DAM

WESTCHESTER COUNTY, NEW YORK
INVENTORY NO. N.Y. 1266

PHASE I INSPECTION REPORT
NATIONAL DAM SAFETY PROGRAM

JULY 1981

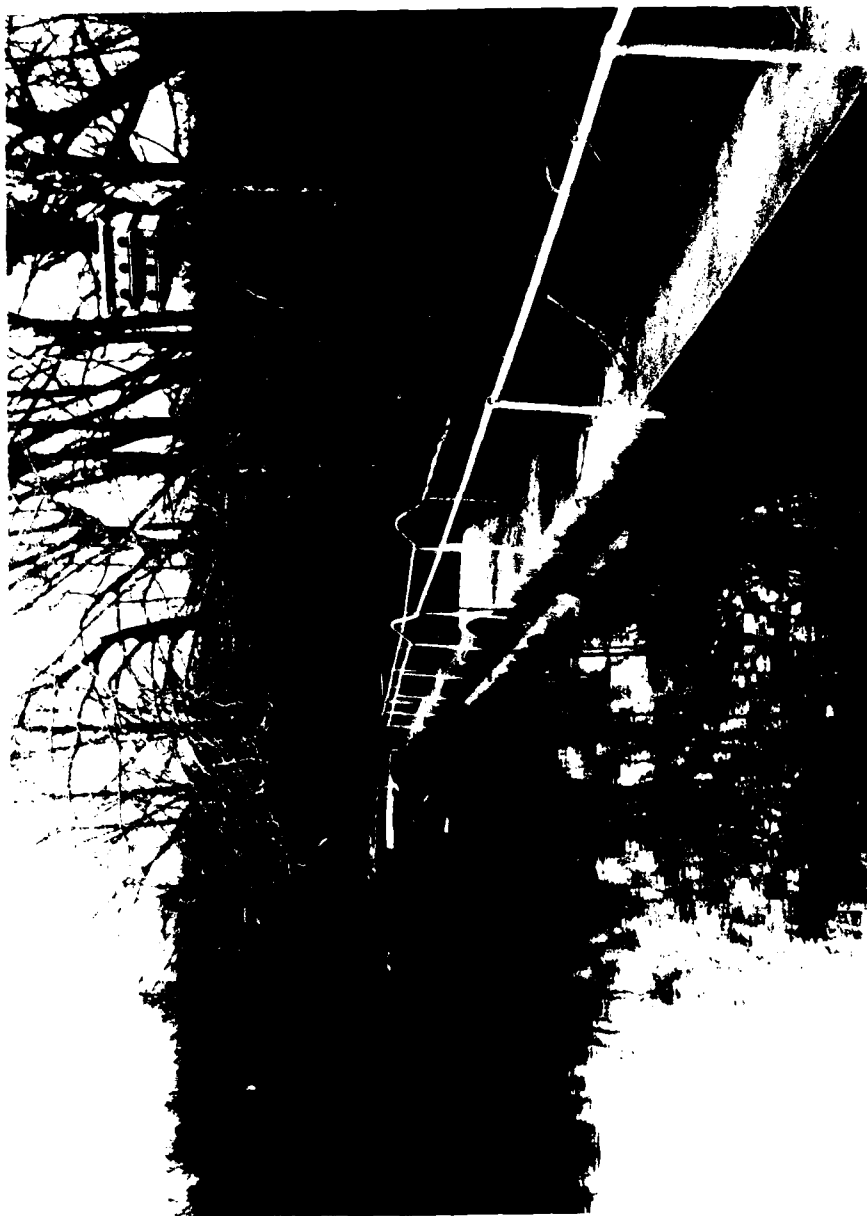
OVERVIEW

The exposed concrete surfaces of the dam appear to be in good condition; no structural cracking or deterioration was observed (See OVERVIEW). The vertical and horizontal alignment of the gravity crest and the downstream earth buttress crest are good. The alignment of the submerged upstream buttress crest could not be determined.

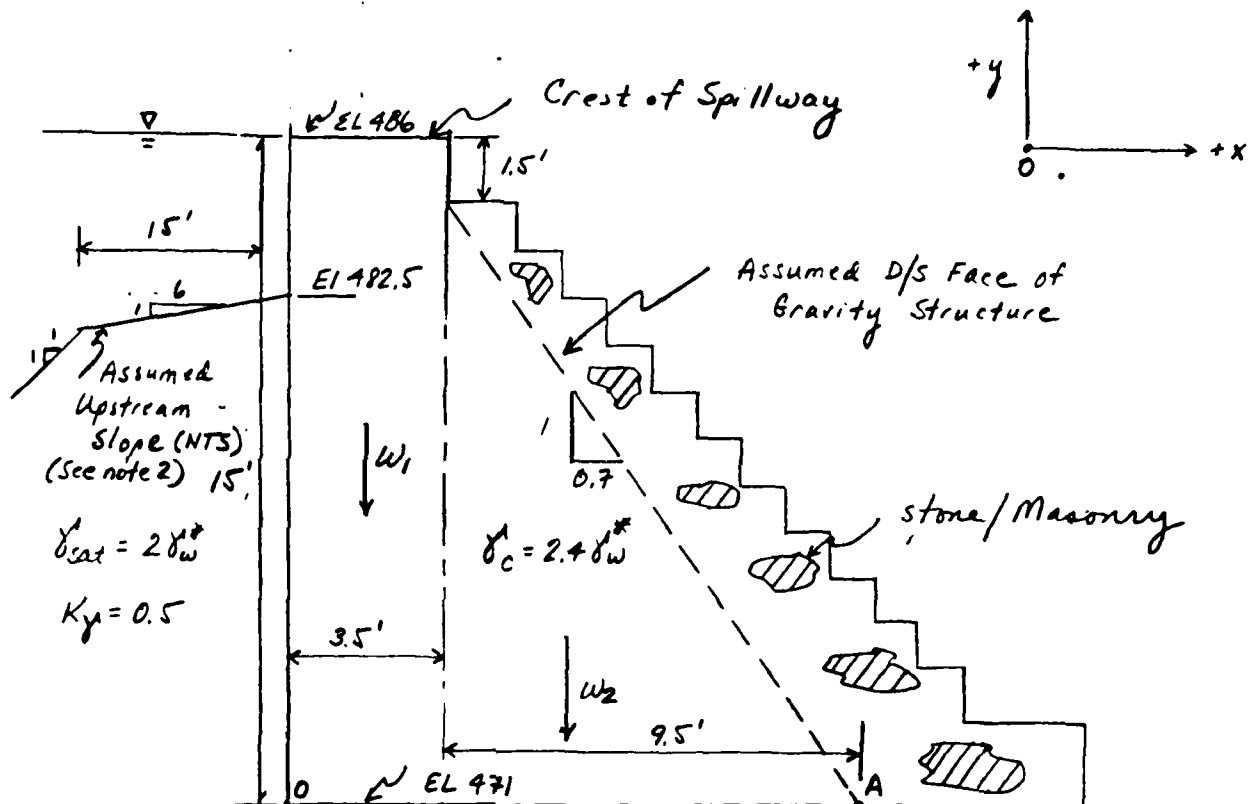
ASSUMED TYPICAL CROSS-SECTION OF OVERFLOW SECTION

The results of the stability analysis indicate that the stability of the section analyzed is inadequate in overturning except for earthquake loading, and inadequate in sliding for all loading conditions. The configuration of the gravity spillway structure and the upstream earth buttress should be determined to more accurately evaluate the stability of the structure. After obtaining this information, an in-depth structural stability analysis should be conducted.

2. Determine the exact geometry of the gravity structure and the material properties of the downstream and upstream earth buttress and foundation. Perform an in-depth structural stability analysis.
